Mobile Intel® Pentium® 4 Processor-M

Specification Update

July 2006

Document Number: 250721-035

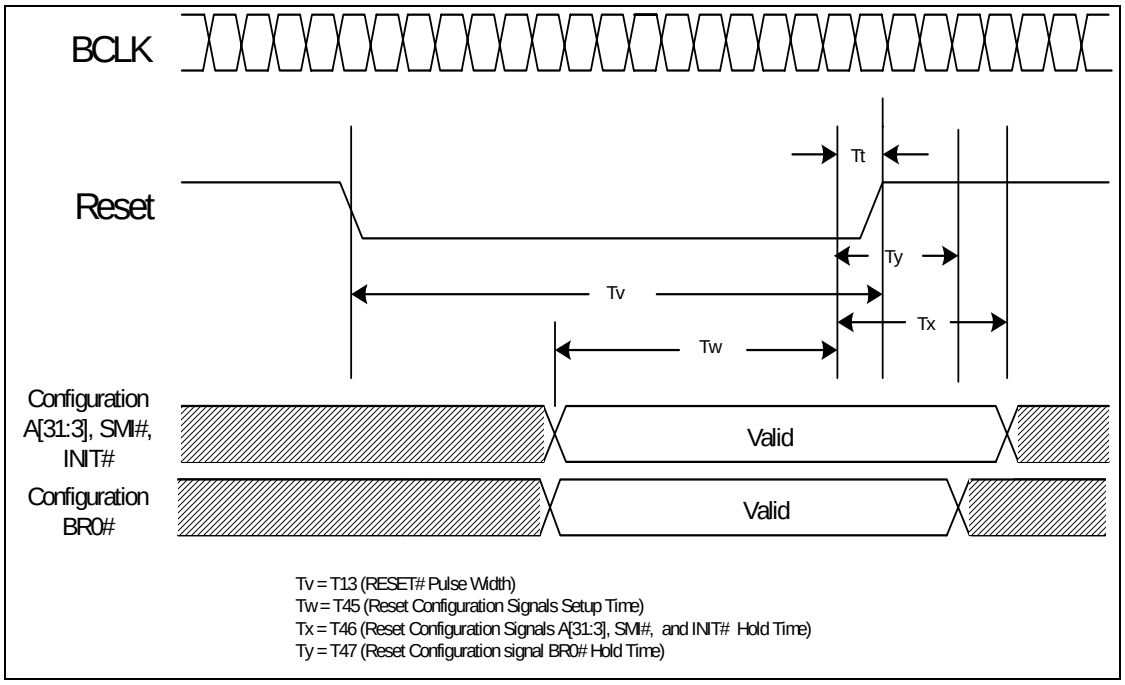
Figure 13. System Bus Reset and Configuration Timings

The BR0# maximum hold time has changed to 2 BCLKs. This change will be shown in the “System Bus AC Specifications (Reset Conditions)” table and “System Bus Reset and Configuration Timings” figure of the *Mobile Intel® Pentium® 4 Processor - M Datasheet*. This change will be incorporated in the next revision of the datasheet.
